PIC18F2455/2550/4455/4550 Rev. A3 Silicon Errata

The PIC18F2455/2550/4455/4550 parts you have received conform functionally to the Device Data Sheet (DS39632D), except for the anomalies described below. Any Data Sheet Clarification issues related to the PIC18F2455/2550/4455/4550 will be reported in a separate Data Sheet errata. Please check the Microchip web site for any existing issues.

The following silicon errata apply only to PIC18F2455/2550/4455/4550 devices with these Device/Revision IDs:

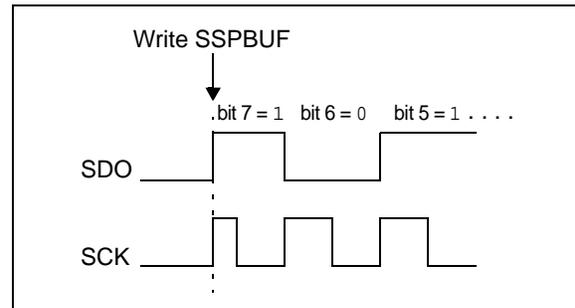
FIGURE 1: SCK PULSE VARIATION USING TIMER2/2

When the SPI is using Timer2/2 as the clock source, a shorter than expected SCK pulse may occur on the first bit of the transmitted/received data (Figure 1).

To avoid producing the short pulse, turn off Timer2 and clear the TMR2 register, load the SSPBUF with the data to transmit and then turn Timer2 back on. Refer to Example 6 for sample code.
